2009 Year 1 Post-Construction Monitoring of the Stuck River Drive Revetment Repair, White River

By Ray Timm and Sarah McCarthy

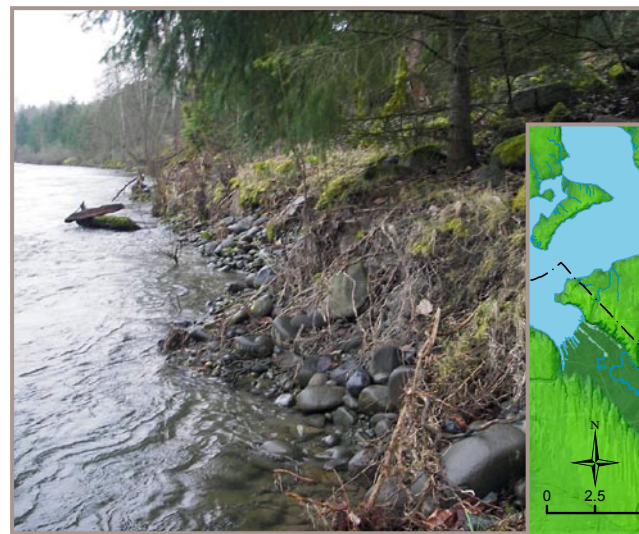
Photo 1. An eroded portion of the Stuck River revetment taken from the White River looking upstream just above the R Street Bridge. Photo: Ray Timm.

A facility inspection following the November 2006 flood revealed damage to the Stuck River Drive Revetment which is located upstream of the R Street Bridge on the White River in Auburn, Washington. The revetment is a flood protection facility made primarily of rock riprap designed to protect the river bank from erosion. The revetment was severely eroded and undercut, requiring repair (Photo 1). The revetment repair, which was completed in 2008, was intended to protect nearby infrastructure while improving aquatic habitat diversity and cover in this segment of the White River.

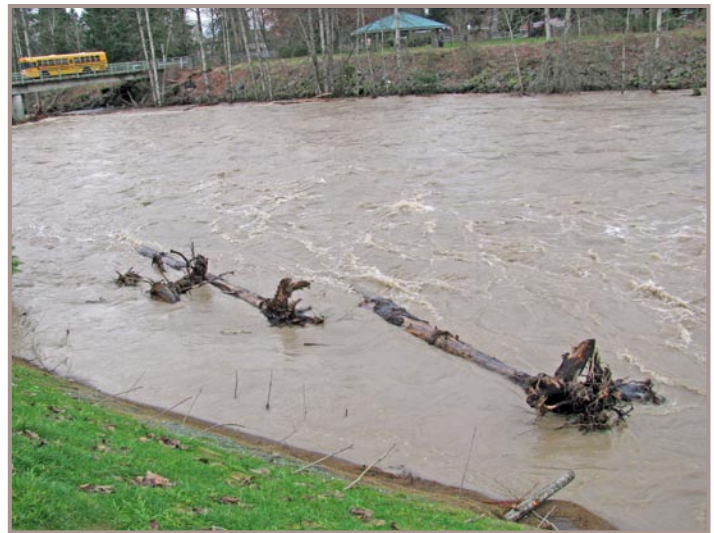
Photo 3. Stuck River Revetment Repair site during 12,200 cfs event, Jan. 9, 2009. Notice the difference in water velocities between the large wood and the bank, and channelward of the wood. Photo: Terry Butler.

The bank was indeed protected from damage during the January 2009 flood. Post-flood inspections revealed an intact facility with no signs of erosion. In addition, visual inspections close to the peak of the storm discovered slower-moving water around the large wood and boulders, contrasted by swift-moving water in the center of the channel (photo 3). A small amount of flood-borne wood floating downstream was recruited to the revetment repair, but did not cause any damage to the facility or anchored large wood.

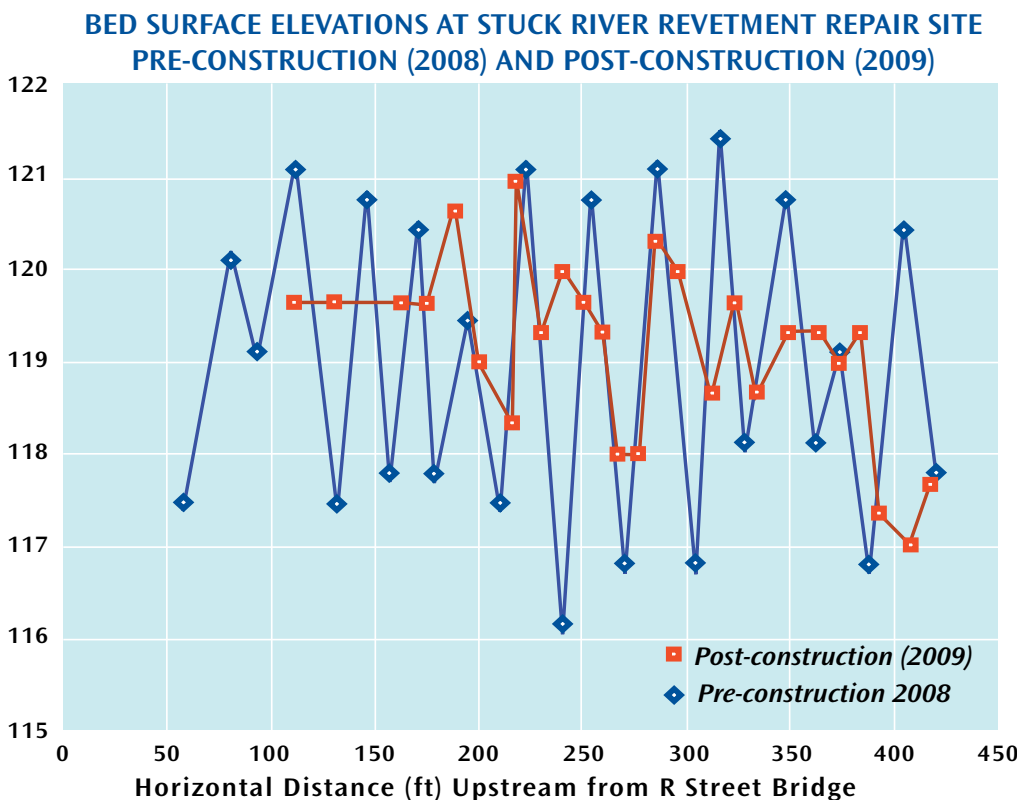
Figure 1.

- First, the revetment was successfully repaired and the bank was protected from damage during the 2009 high flow event that was comparable to the 2006 flow discharge that caused the flood damage to the facility. Therefore, the first project objective was met.
- Second, it appears that slower water velocities and/or high sediment loads in the White River caused sedimentation along the toe of the facility. Habitat complexity was increased initially through the placement of large wood and boulders, but may have been slightly reduced by the sediment deposition.
